DUGWAY PERMIT

MODULE VII

HWMU 2 POST-CLOSURE PLAN

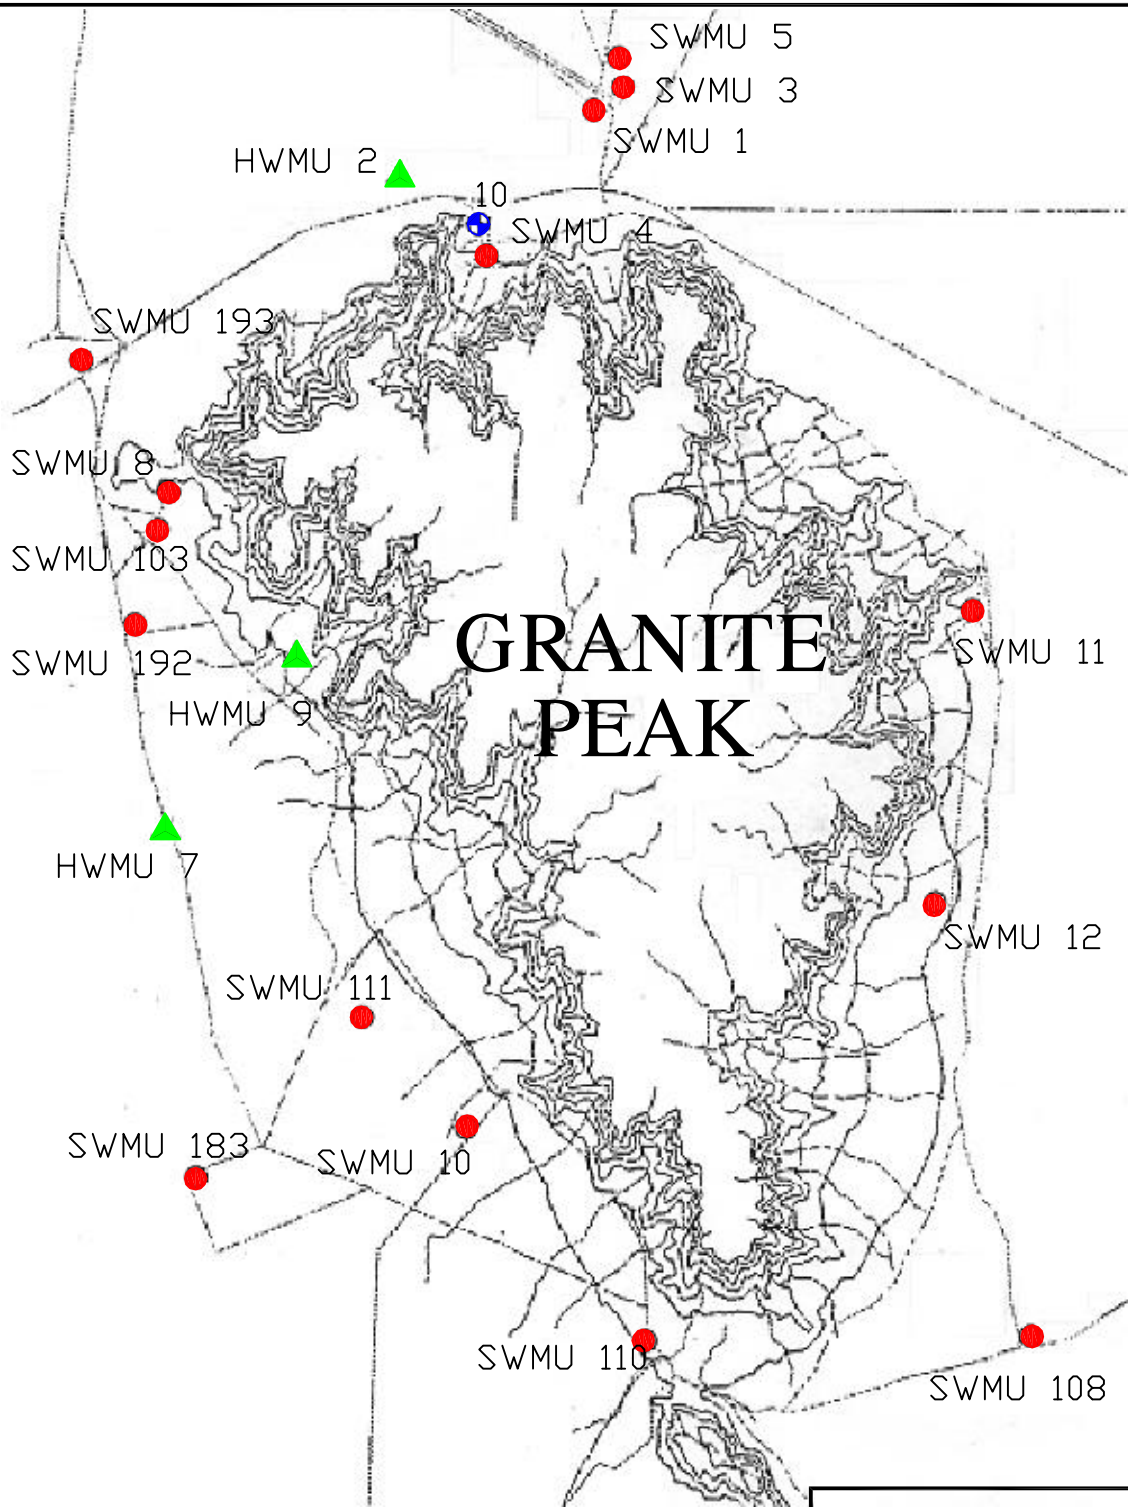
FIGURE 2-1
DUGWAY PROVING
GROUND INSTALLATION
DUGWAY PROVING GROUND
DUGWAY, UTAH

The following provides a general description of HWMU 2, also known as the Waste Pile at the North End of Granite Peak at Dugway (Figure 2-1). The facility information requirements specified in UAC 315-3-2.5(d) for Solid Waste Management Units (SWMUs) is addressed under the Dugway Proving Ground Storage Permit. A general description of the Dugway installation can be found in Module VII, Attachment 1.

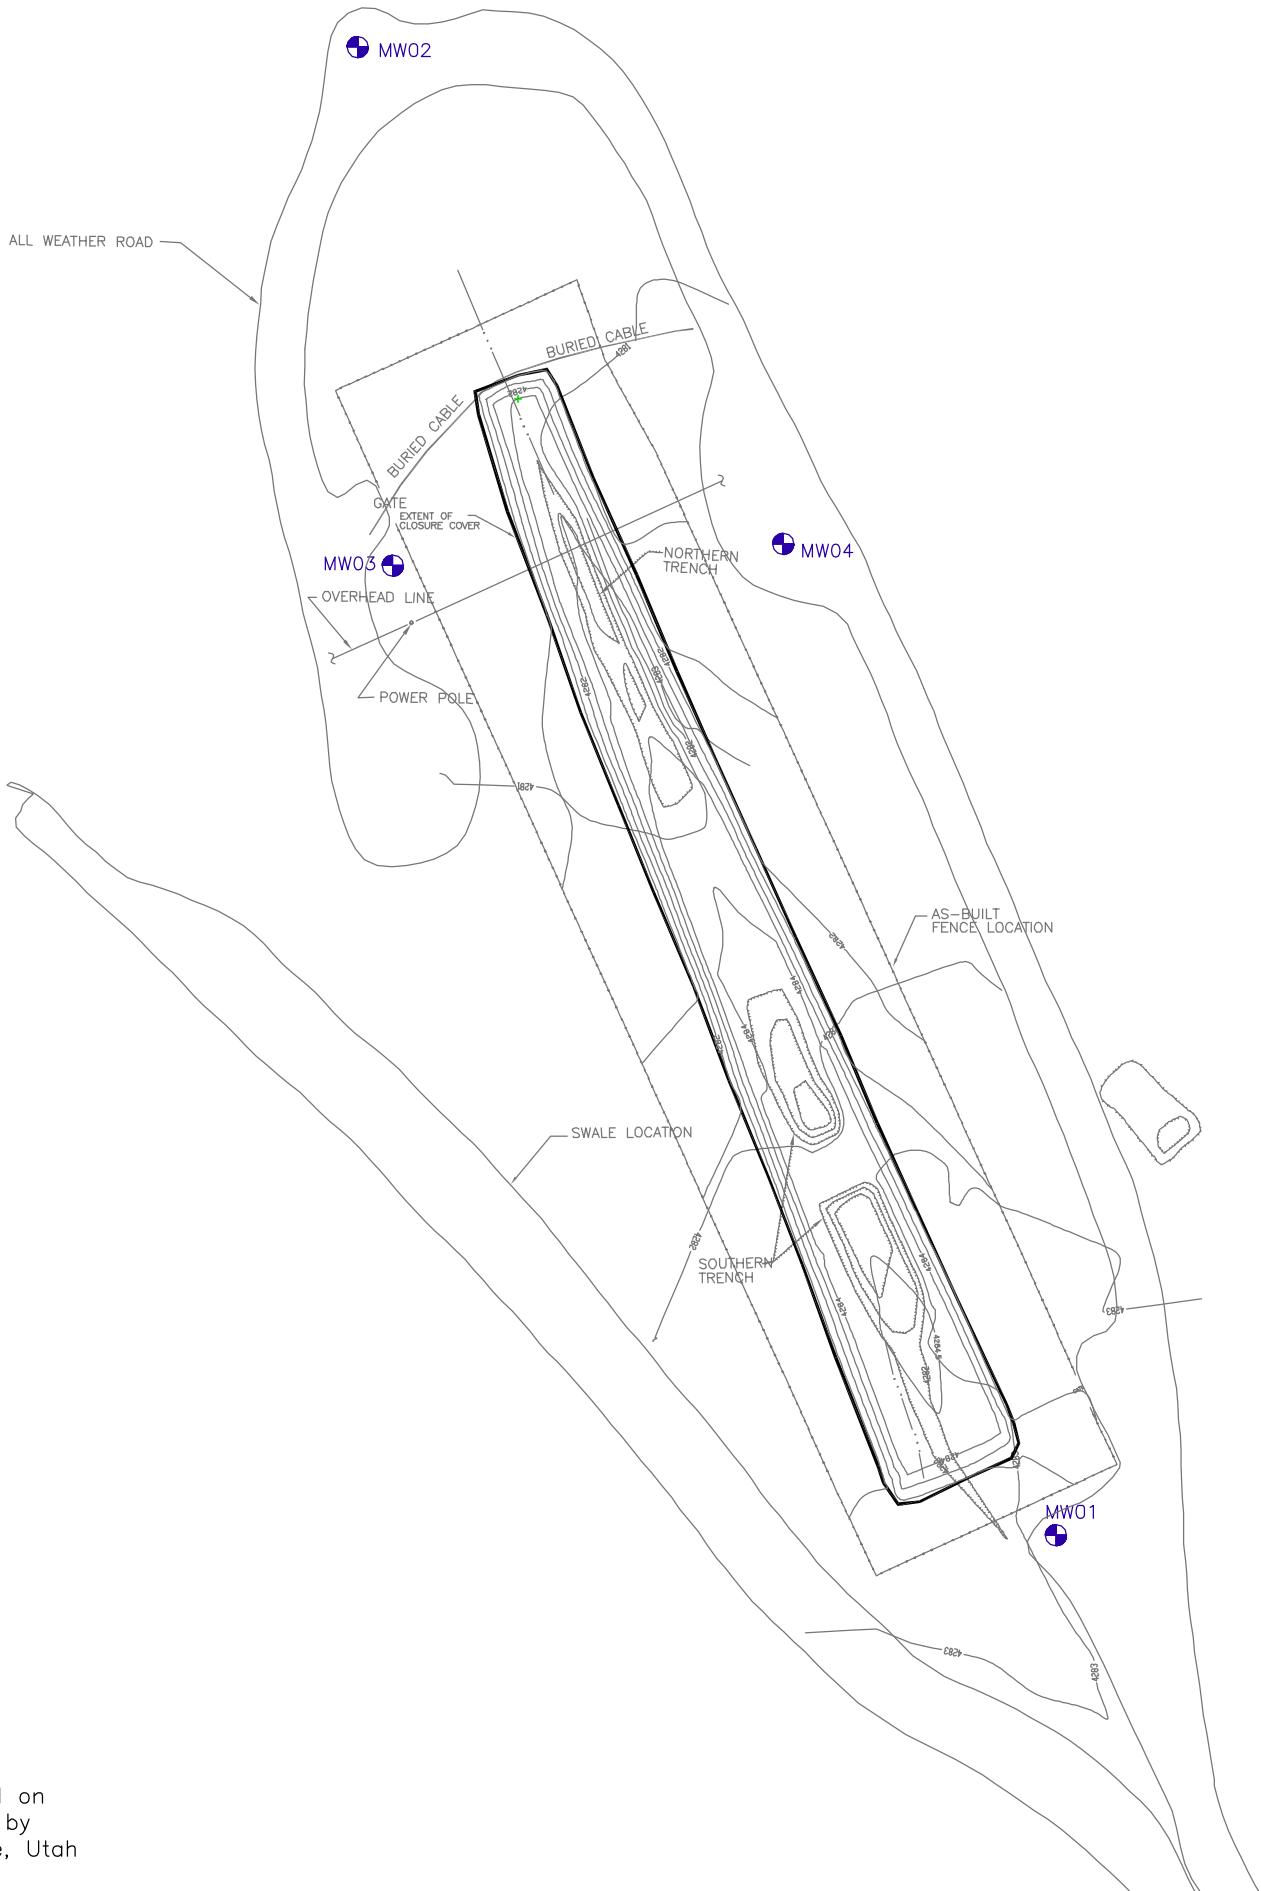
FIGURE 2-3
HWMU 2
LANDFILL
POST-CLOSURE MONITORING WELLS

Reference: Topography shown is based on As-built survey completed June 2002 by Thompson-Hysell Engineers, Taylorsville, Utah

Four shallow groundwater monitoring wells (MW01, MW02, MW03, and MW04) were installed at HWMU 2. Sampling of these wells since 1995 has resulted in no data indicating a release to groundwater at HWMU 2. Groundwater is also classified as non-potable.

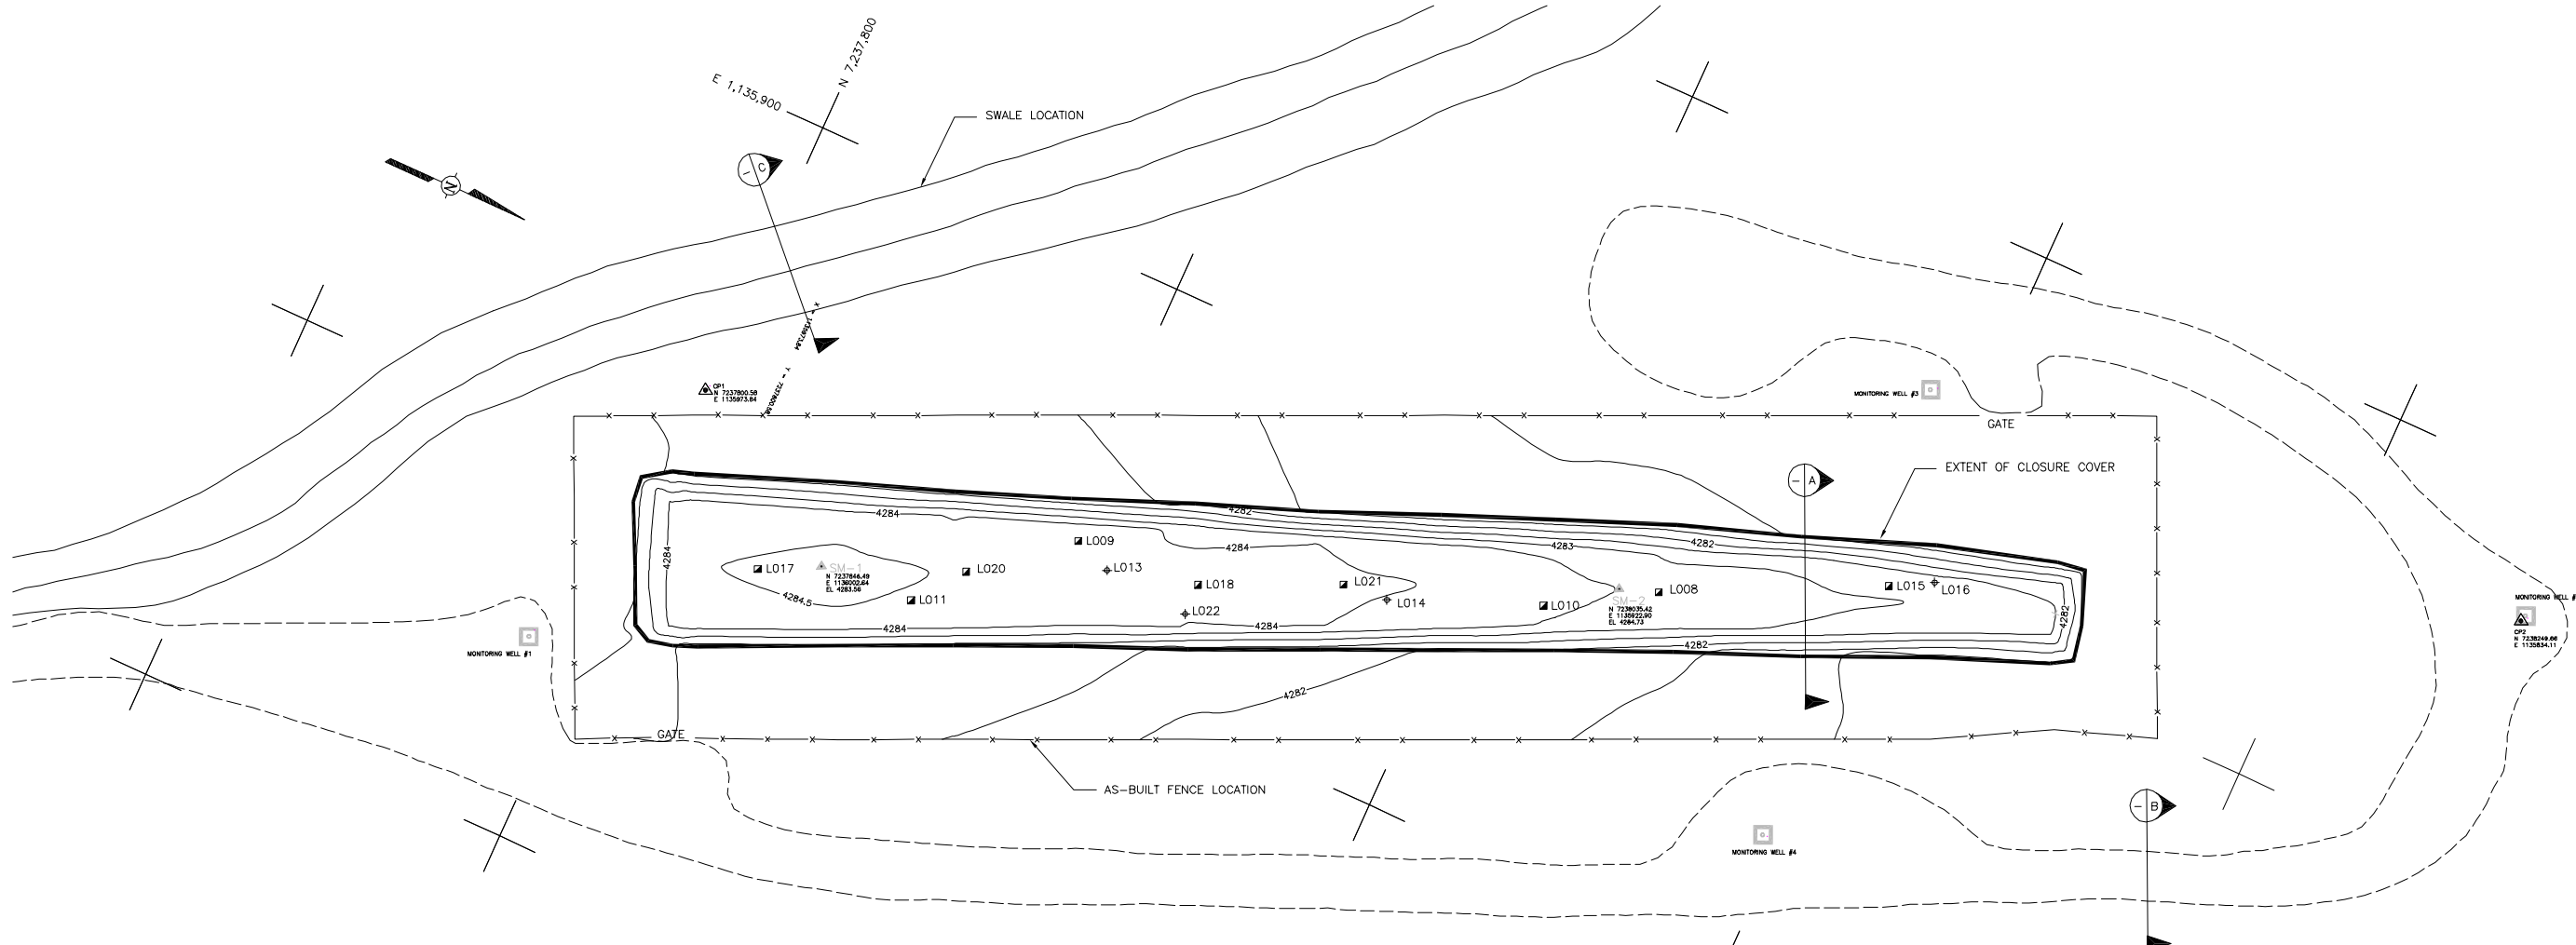
REFERENCE:
AS-BUILT SURVEY COMPLETED JUNE 2002
BY THOMPSON - HYSSELL ENGINEERS, TAYLORSVILLE, UTAH

All construction activities were completed in accordance with applicable UAC regulations, the Remedial Action Plan, the 100% Design Report, and approved Field Work Variances (FWVs). Figure 2-4 shows the post-closure configuration of the HWMU 2 engineered soil cover and existing site conditions.
